# **Tollgate Property Owners Association Forest Health and Wildfire Mitigation Plan**

**September 2025**

This Wildfire Mitigation Plan was requested by the Tollgate Property Owners Association to support continued wildfire hazard mitigation efforts. This document is intended to address needed actions to increase resilience to wildfire within the area included in the Tollgate Subdivision.

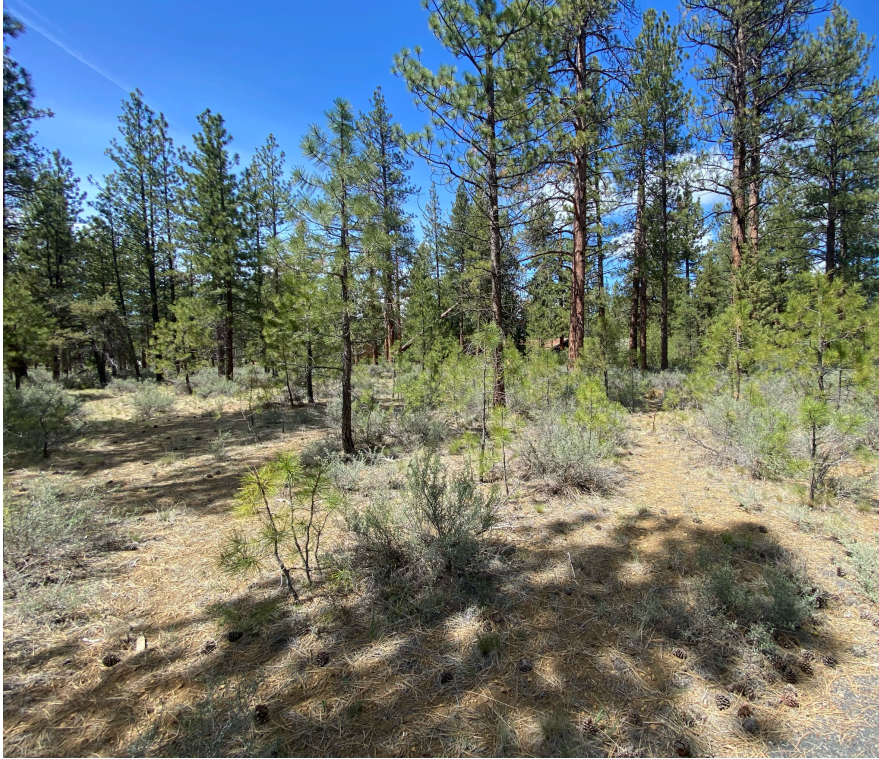
**Photo 1: Common Area: note the brush and dense overstocking of reproduction (second growth trees).**

- Remove all juniper trees.
- Remove all diseased trees.
- Thin stands of ponderosa pines to provide for:
  - 15 foot spacing between crowns of individual trees, or
  - 25 foot spacing between crowns of small groups (2-5) of trees.
- Remove conifer trees that serve as ladder fuels.

- Remove 80% of the brush on the parcels.
- Remove all brush equal to or greater than 3 feet tall.
- Ensure brush near or under the dripline of trees is removed.

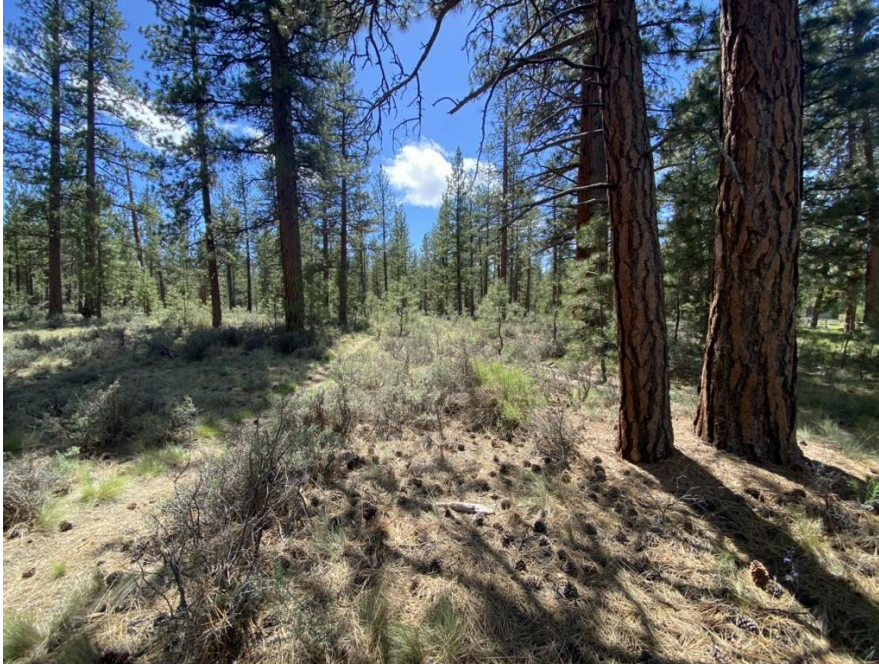
**Photo 2:** Heavy fuel loading with bitterbrush and young ponderosa pines in the Trout Creek Conservation Area.

Adjacent to Tollgate, the Trout Creek Conservation Area to the south has a heavy fuel load with bitterbrush and an overstocking of young ponderosa pine. This could lead to rapid fire growth if a wildfire were to start before this area is treated. The US Forest Service lands have been treated in the recent past, but need to be monitored to ensure maintenance treatments are completed in the future.

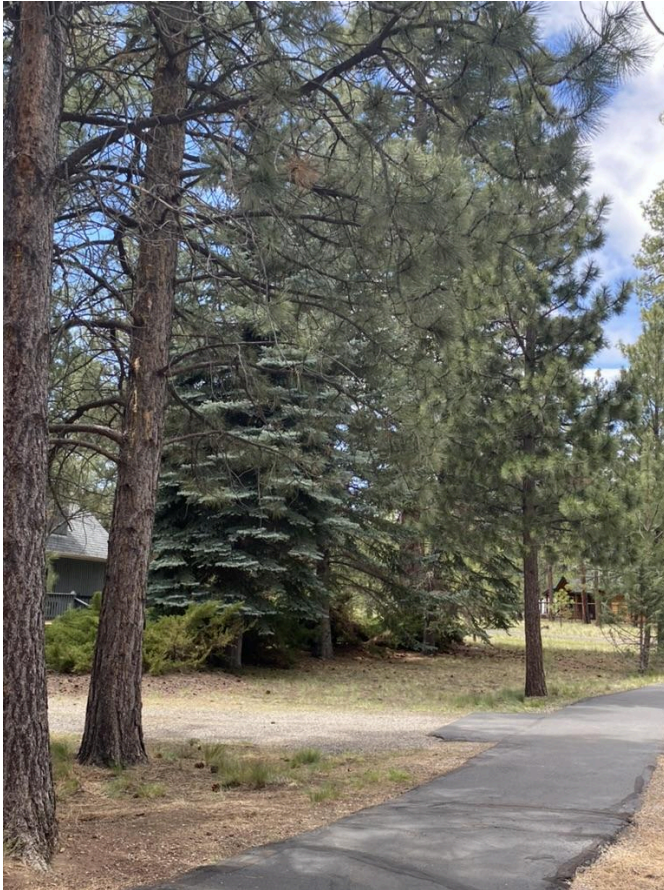
**Photo 3: Example of landscaping in a common area frontage that is a fire hazard (highly flammable spruces, evergreen boughs not limbed to 6 feet off the ground, ladders fuels).**

- Renegotiate the requirement for Common Area irrigation (45 properties). Many of these areas have been planted with trees that are a high hazard (i.e. spruce trees with boughs to the ground) in the event of a wildfire.
