# **Tollgate Property Owners Association Forest Health and Wildfire Mitigation Plan**

**September 2025**

This Wildfire Mitigation Plan was requested by the Tollgate Property Owners Association to support continued wildfire hazard mitigation efforts. This document is intended to address needed actions to increase resilience to wildfire within the area included in the Tollgate Subdivision.

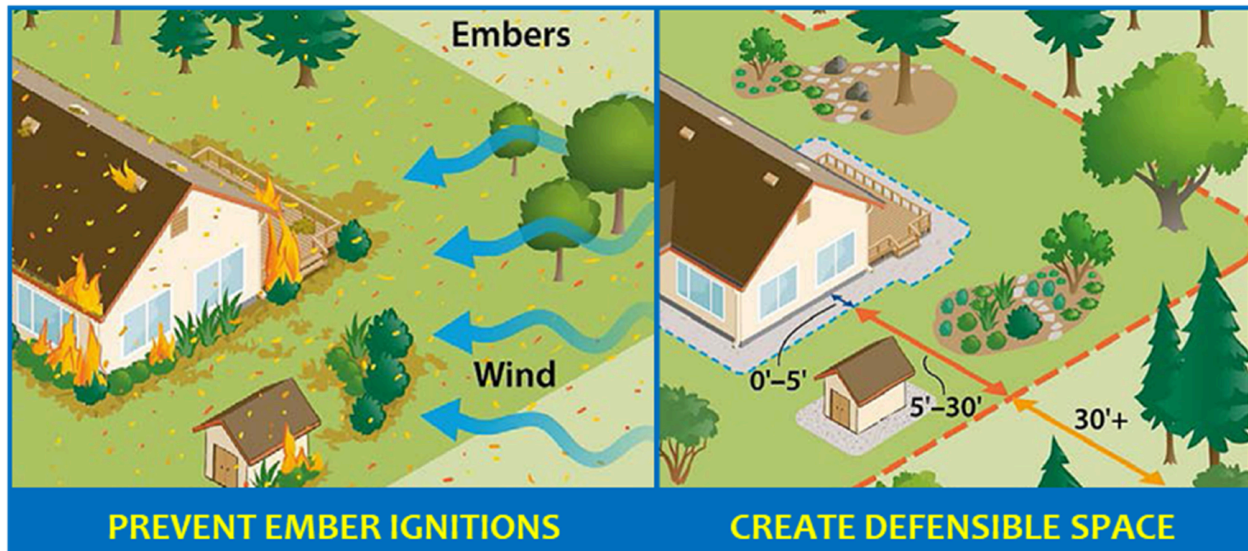
- Clustered shrubs must not exceed 15 feet in combined width (treated as an individual shrub) and must not form continuous rows or privacy rows.
- Individual shrubs, bushes, and plants, or groupings must have a minimum horizontal spacing that is twice the height of the tallest plant from other trees, shrubs, or plants (e.g., A 3-foot-tall shrub requires 6 feet spacing).
- Remove shrubs and plants from under larger trees.
